PROPERTY INSPECTION REPORT

Prepared For: Client's Name Here
(Name of Client)

Concerning: Property Address Here
(Address or Other Identification of Inspected Property)

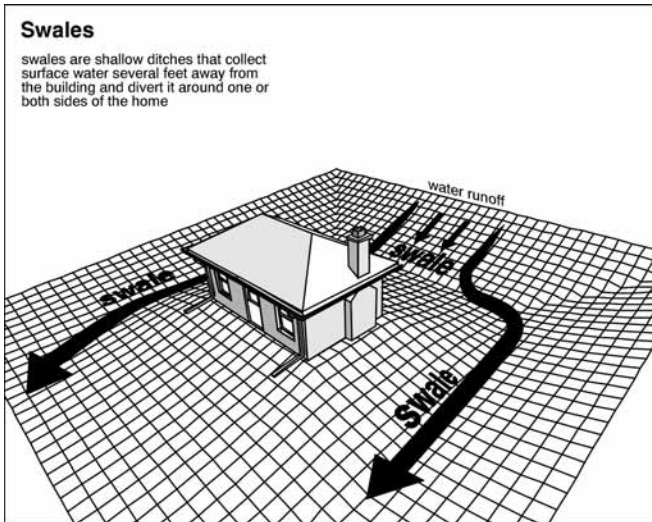
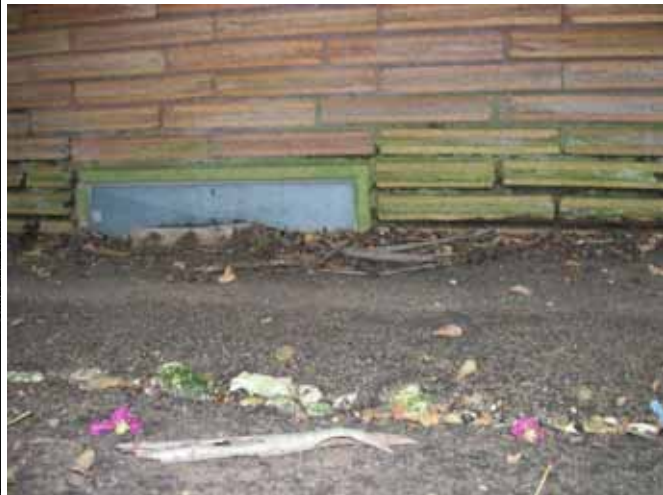
- Poor to negative site drainage was observed on the north and northwest sides of the house. Proper drainage is needed to help prevent water from standing and/or ponding next to the foundation beam. Corrective measures may be needed if the water stands within 10-feet of the foundation perimeter beam for more than 24-hours.
- The soil line is too high on the east side of the house. Under current building standards there should be at least 4-inches of foundation visible below masonry veneer and 6-inches of foundation visible below wood type veneer.

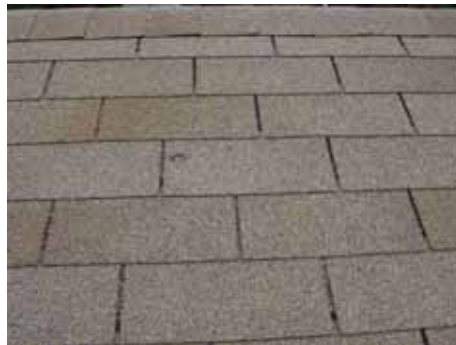
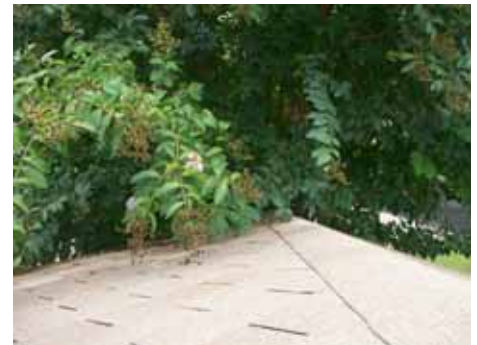
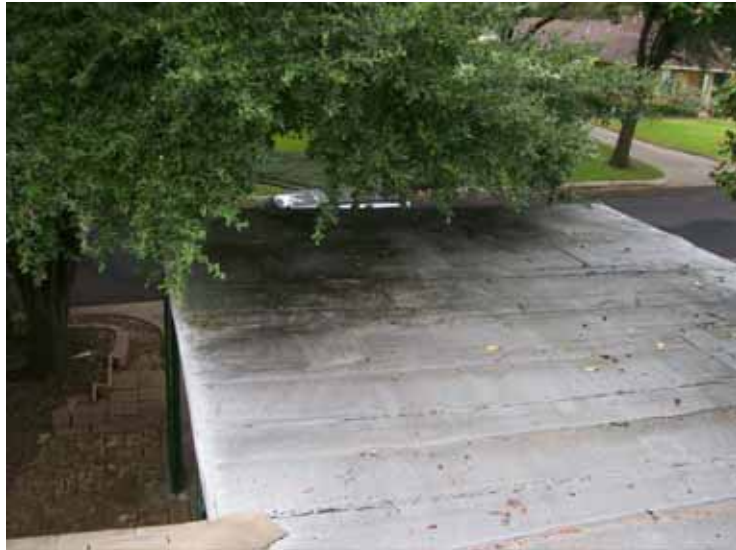
- The roof covering over the carport area is in poor condition and is leaking. The roofing material will need to be replaced.
- The roofing material observed to have impact damage in various locations. The impact damage may have been caused by a previous hailstorm and should be further evaluated.
- Roof fasteners (nails and/or staples) observed to be exposed and should be properly sealed at the ridge caps and flashing areas.
- Damaged shingle tabs were observed on the north, east and south sides of the roof structure.
- High shingle fasteners (staples and/or nails) observed in various locations.
- Some discoloration of the roofing material was observed at the time of this inspection.
- There are some defects and/or raised spots in the roofing material on the north side of the roof structure.

You are strongly encouraged to have your Insurance Company and/or properly certified roofing contractor to physically inspect the roof, *prior to closing*, to fully evaluate the insurability and condition of the roofing material. The observation made to support the rendering of this opinion are listed but not limited to the following:

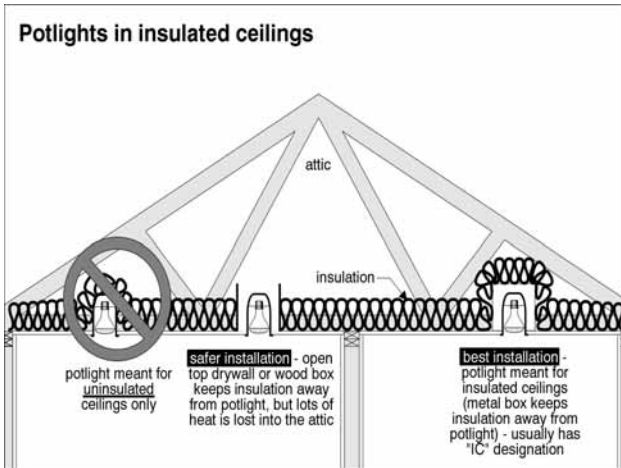
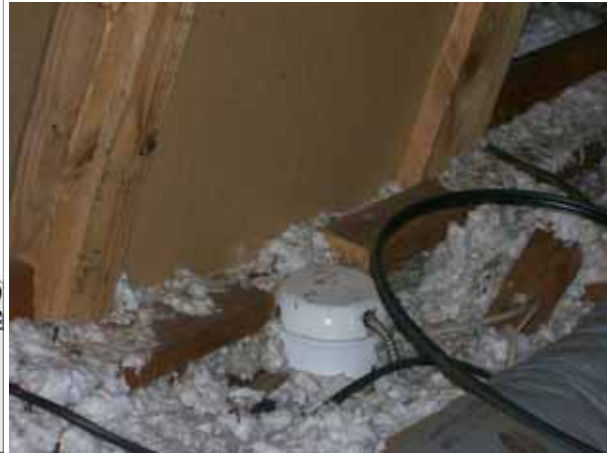
- The carport roof structure is in poor condition and is in need of repair at this time.
- The soffit is sagging and/or pulling loose over the carport area.

- Some separation in the diagonal splice of the hip ridge board was observed over the garage conversion. The diagonal splice in the hip ridge board needs to be supported over the garage area.

- Attic insulation observed to be covering recessed lights. The insulation should be moved away from all recessed lights.
- The skylight sidewall insulation was observed to be pulling loose and/or missing in the attic area. This condition should be further evaluated and corrected as necessary.

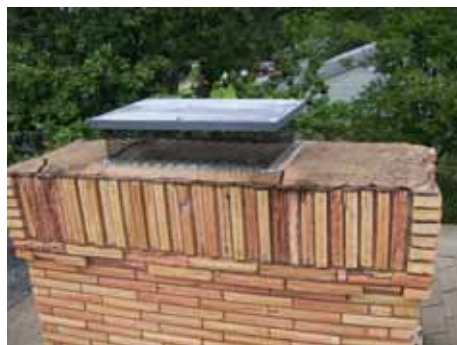
- Caulking improvements are recommended for the area between the exterior veneer and the window frames.
- The wood veneer has some deterioration and/or damage on the west side of the house.
- The roof level chimney structures brick veneer has some deterioration and/or damaged.

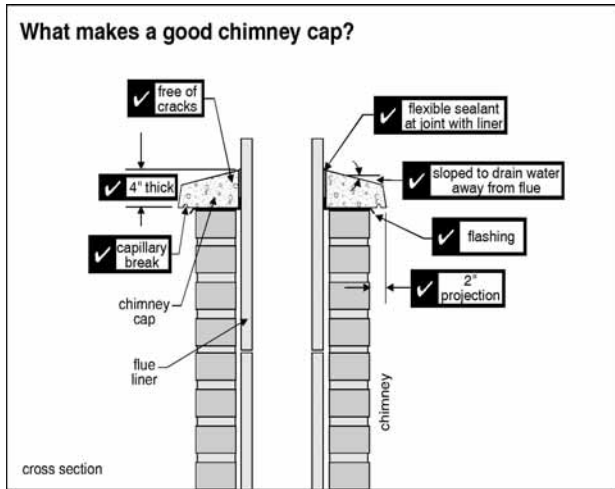
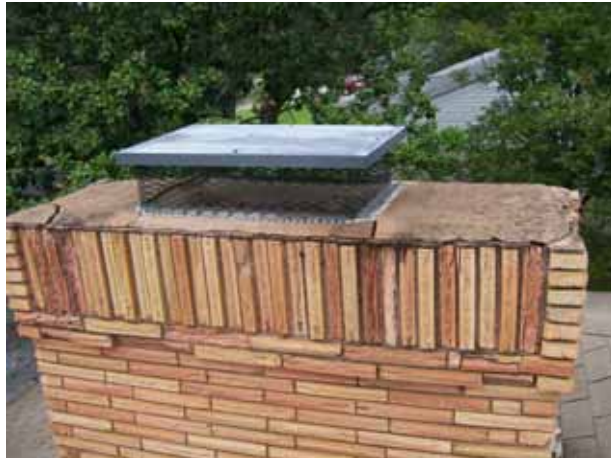
- The gas was turned off at the time of this inspection. I was unable to check the gas operation of this component at this time.
- The chimney flue needs to be cleaned by a Qualified Chimney Sweep. A creosote / soot build-up was observed in the visible flue area.
- The roof level chimney mortar cap/crown is in need of improvement.

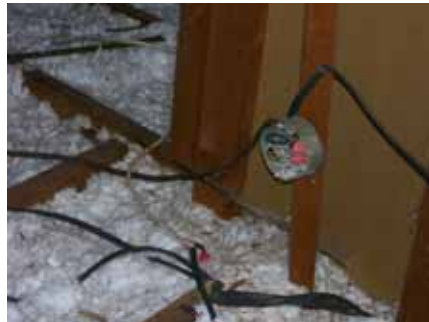
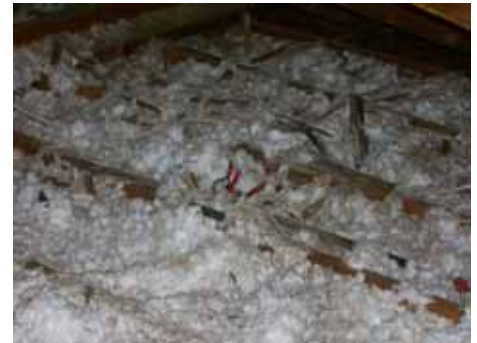
- Open electrical junction box(es) were observed in the attic area. All open junction box(es) in the attic should be properly enclosed. Open junction box(es) were located over the garage area.
- Spliced electrical wires were observed in the attic area. Spliced wires in the attic should be properly enclosed in junction box(es) and secured to the ceiling joist. Spliced wires were located over the kitchen area.
- Open electrical junction box(es) were observed in the crawl space area. All open junction box(es) in the crawl space should be properly enclosed.
- Spliced electrical wires were observed in the crawl space area. Spliced wires in the crawl space should be properly enclosed in junction box(es) and secured to the floor joist or girder.

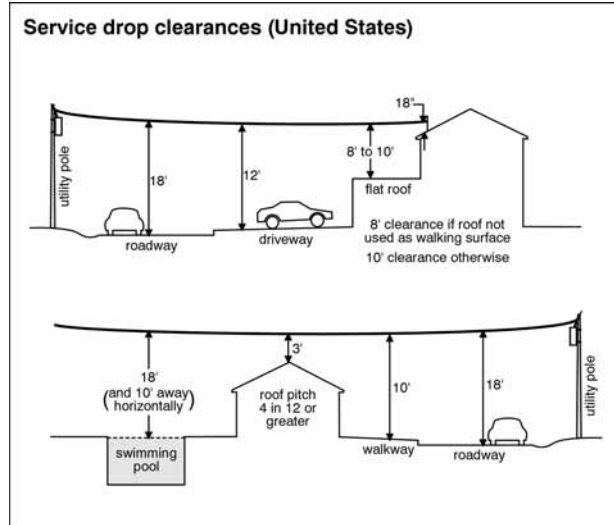
- The electrical service wires hang to low across the back yard area. The electrical service wires from the service pole to the house should clear the ground and/or deck by ten (10) feet.

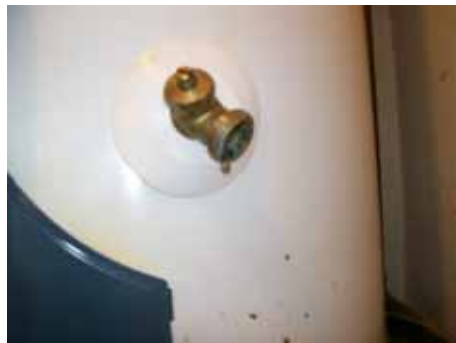
- The gas service was turned off to the home at the time of this inspection. I was unable to check the gas operation of this component at this time.
- The lower drain plug on the water heater was observed to be leaking at the time of this inspection.
- The supply piping shows evidence of corrosion where it meets the water heater.
- The water heater flue (vent pipe) has inadequate clearance from combustible materials. Double walled vent pipes should have at least one-inch (1”) of clearance and single walled vent pipes should have at least six-inches (6”) of clearance from combustible material.
- The water heater exhaust flue pipe that passes through the ceiling was observed to be an older single wall pipe. Under current building standards, the exhaust flue pipe that passes through the ceiling should be double walled and have at least one inch (1”) of clearance around the vent pipe.

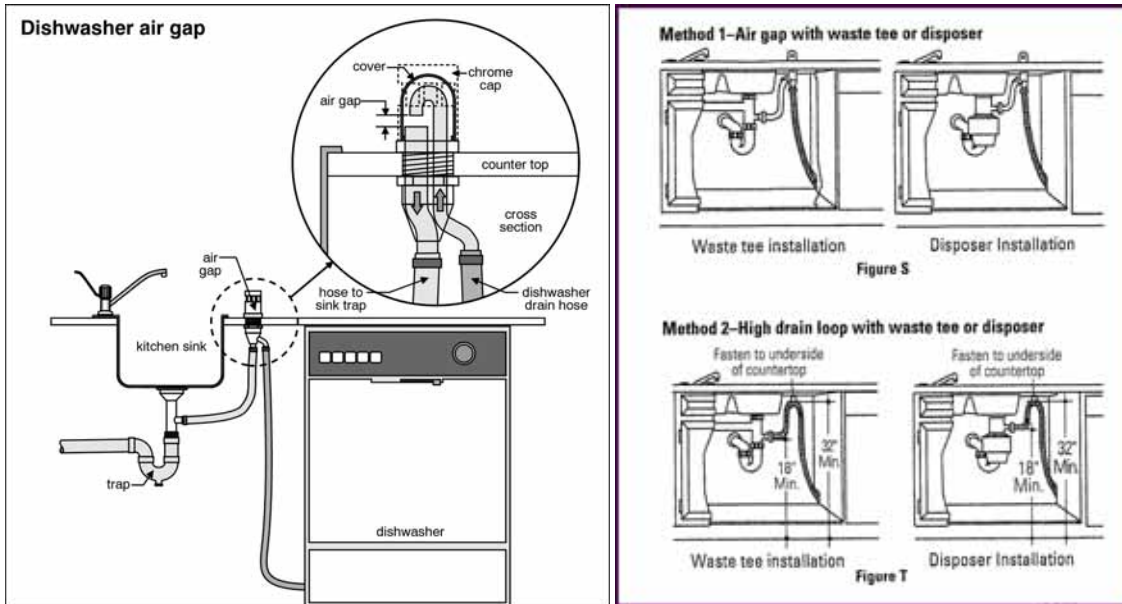
- The dishwasher drain hose is not properly installed to prevent back flow or anti-siphoning. It is recommended that an air gap device or hose loop be installed in the drain line.
