P.O. Box 151652 Arlington, Texas 76015
 Metro 972-572-4500 Metro 817-467-0213
 www.a-action.com

PHASE 1 PROPERTY INSPECTION REPORT

Part 1: TYPE OF HOME

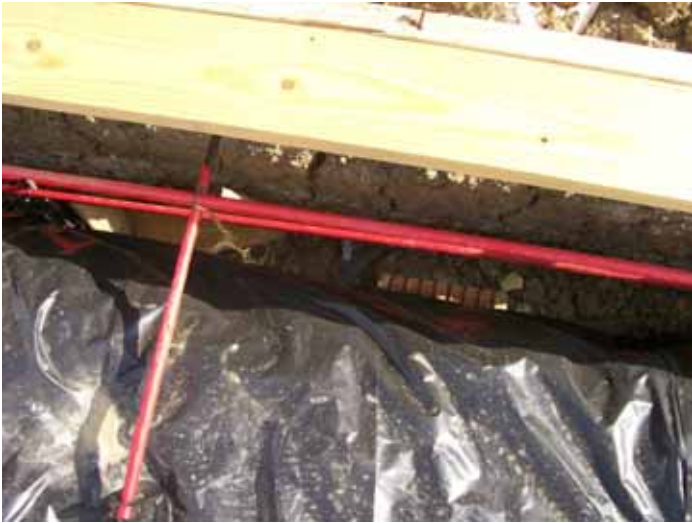
Debris needs to be removed from the crawl space.

8. All debris in the foundation beam trenches needs to be cleaned out before the concrete is poured.
9. It is recommended to add two addition steel rebar stands in the lower portion of the large footer in the back porch.

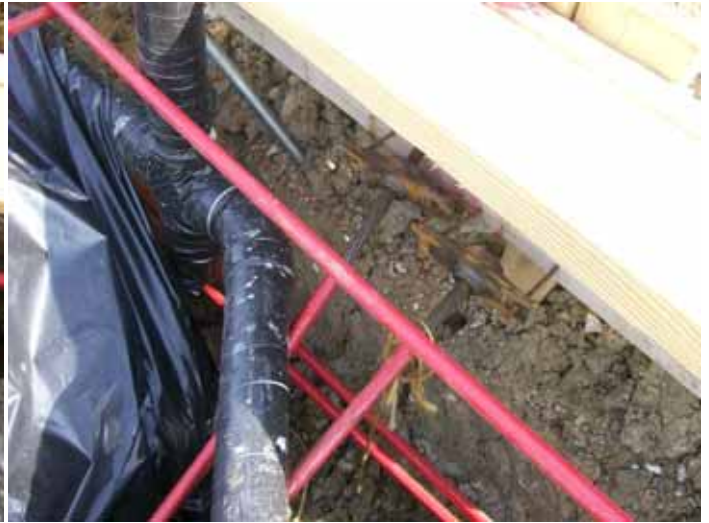
Cable ends need to be wrapped. Plumbing lines need to be insulated.

1. There is damaged and missing post tension cable sheathing at the ends in various locations. The tension cables should be covered at all points from beginning to end. This condition should be corrected prior to pouring the concrete. All of the exposed post tension cable ends should be wrapped with Teflon tape and/or 6-mil plastic. These help prevent the concrete from adhering to the post tension cables.

12. The Pex water lines are not properly protected and/or covered with insulation. This condition should be corrected prior to pouring the concrete.
13. The waste pipes are not properly protected and/or covered with insulation. This condition should be corrected prior to pouring the concrete.

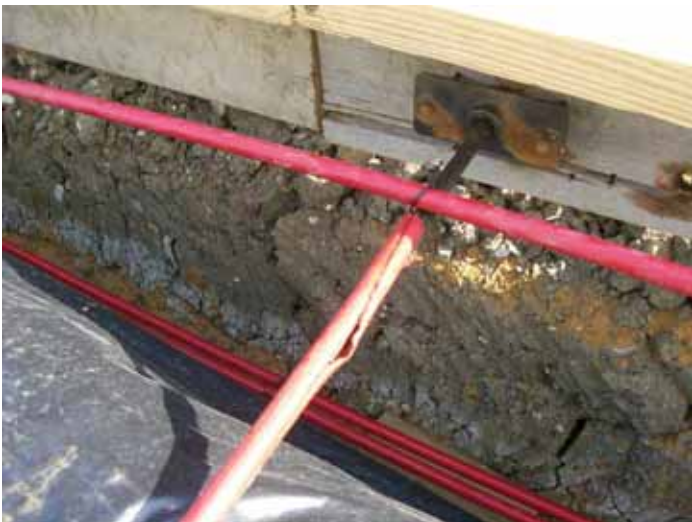
Cable ends need to be wrapped.

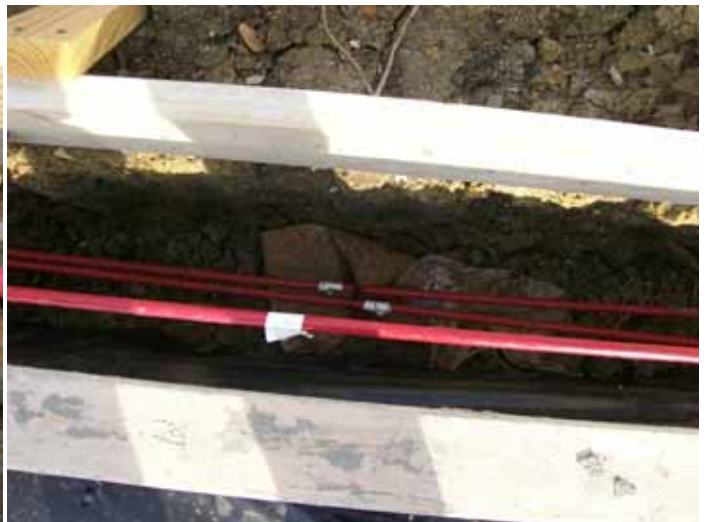
Debris needs to be removed from the crawl space.

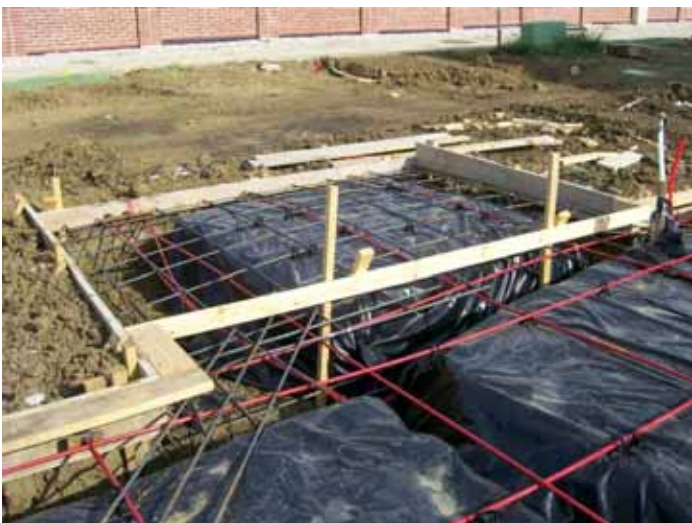
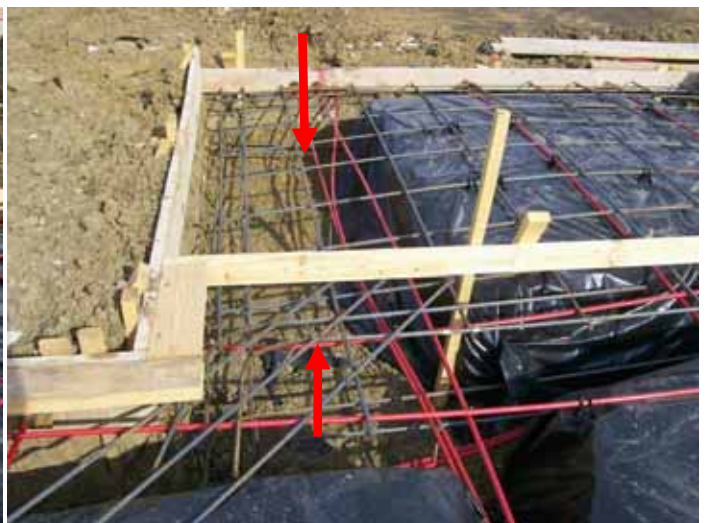
Recommend adding rebar in the lower footer.

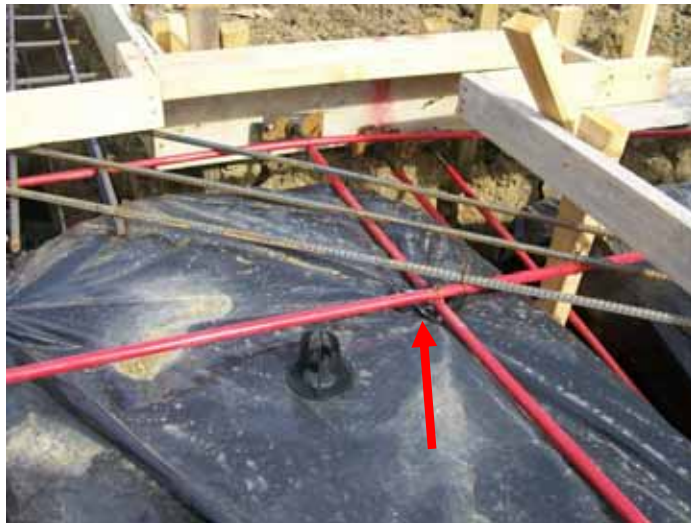
Chairs are needed under the cables and steel near the back porch area.

4. All of the post tension cables need to be properly raised off of the pad floor and suspended a minimum of 2-inches off the finished grade at and around the back porch area.

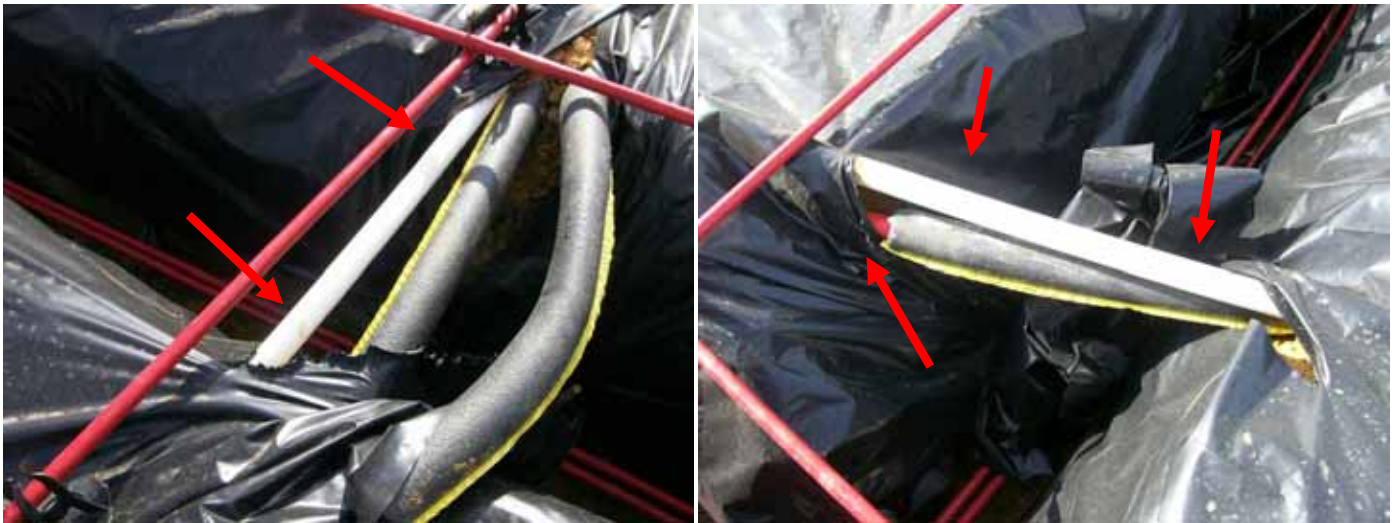
The plumbing needs to be covered with insulation.

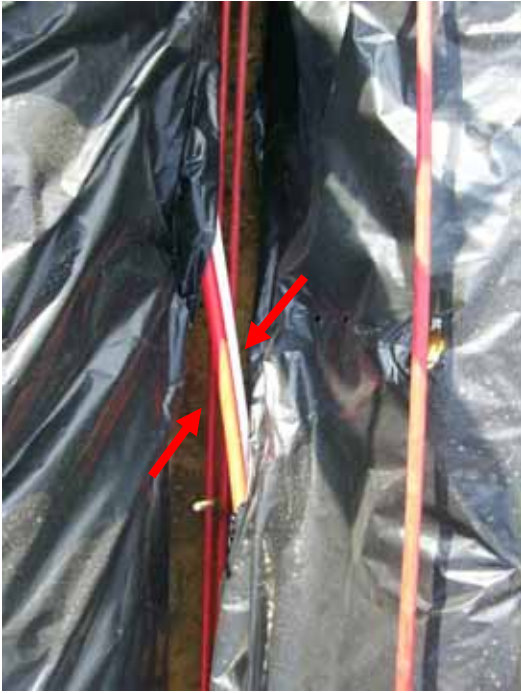
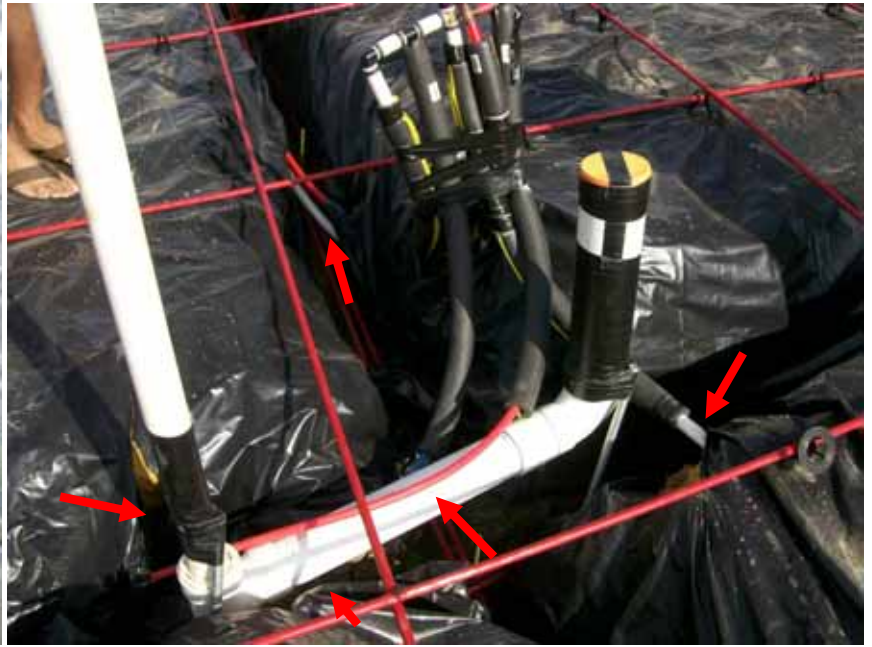
The plumbing needs to be covered with insulation.

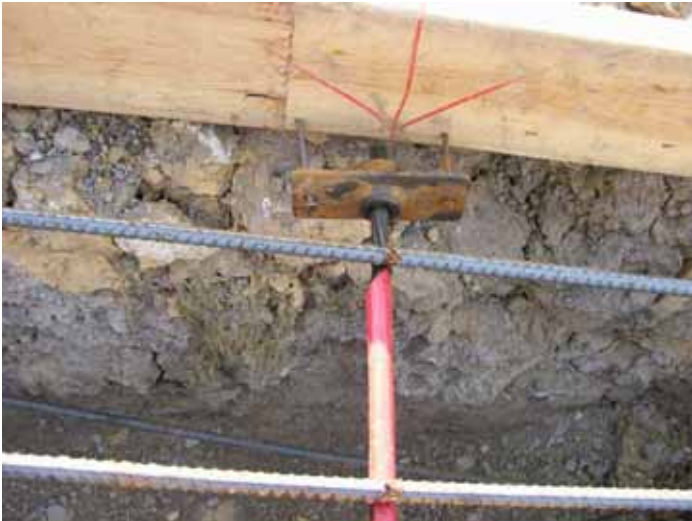
Cable ends need to be wrapped.

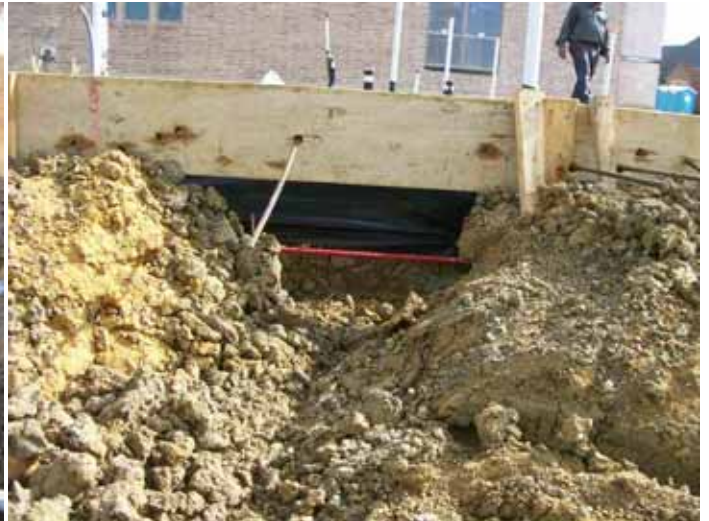
Fill needed against the former boards.

10. It is recommended to add two addition steel rebar strands in the lower portion of the front porch footer.
11. Backfill dirt is needed on the south former board.

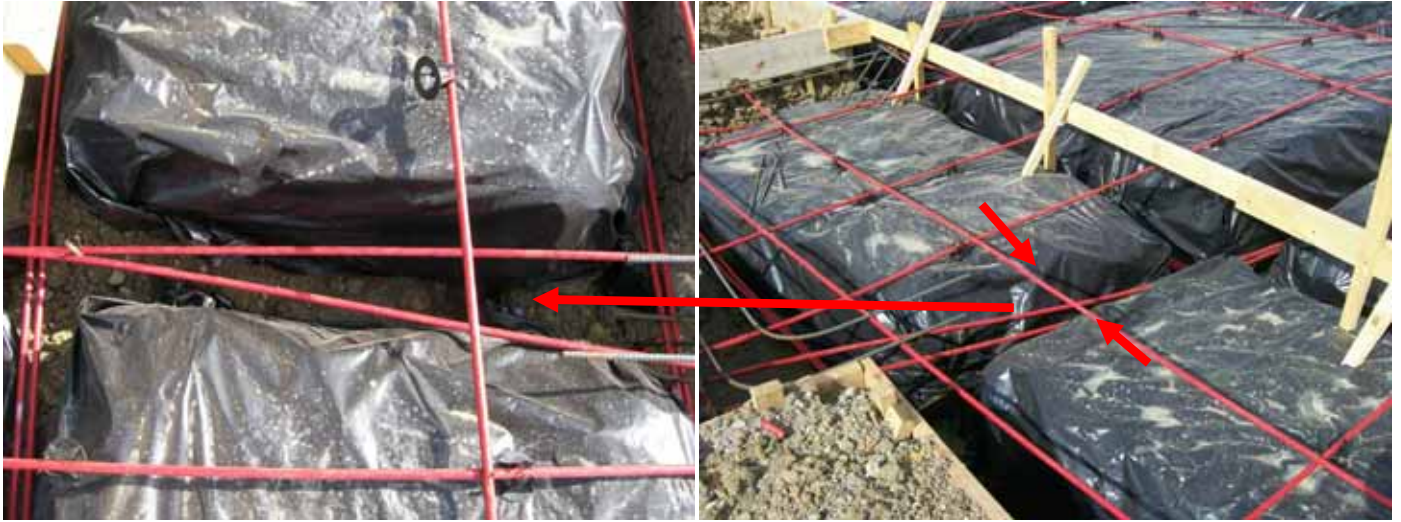
The beam needs to be widened in the front porch area.

2. One of the beams needs to be widened in the front porch area. The beam measured 10-inches. The beam should be a minimum of 12-inches wide.
3. The steel rebar is in contact with the post tension cable at the front porch area. The tension cable should be wrapped with plastic or Teflon tape before the concrete is poured.

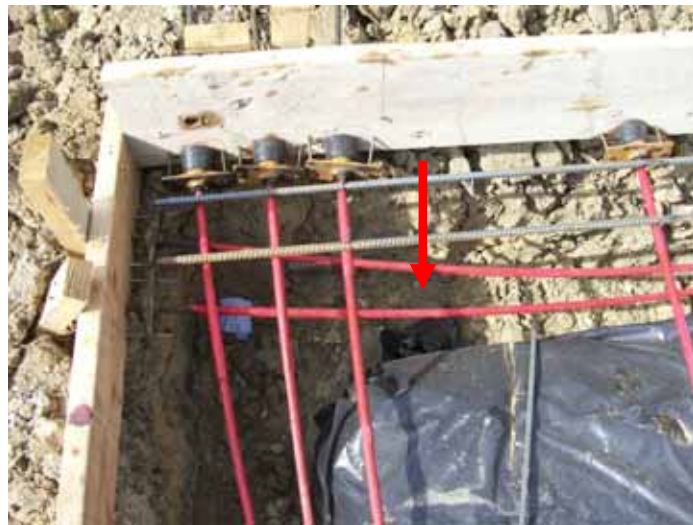
It is recommended to have two additional steel rebar strands in the beam footer at the front porch.
